Manhole Inspection Summary

Manhole # S35GG1015MH

Insp Date: **1/30/07 8:12 AM**

Location Address: **SAINT PAULST**

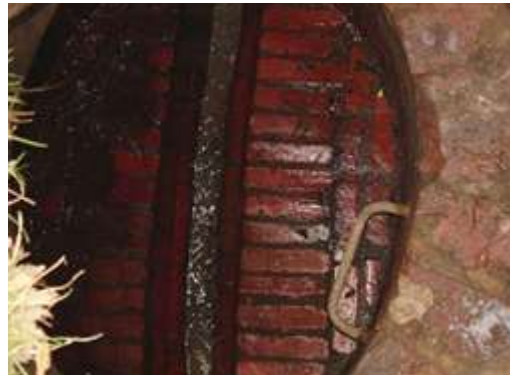
Top View

Frame offset. Bench debris.

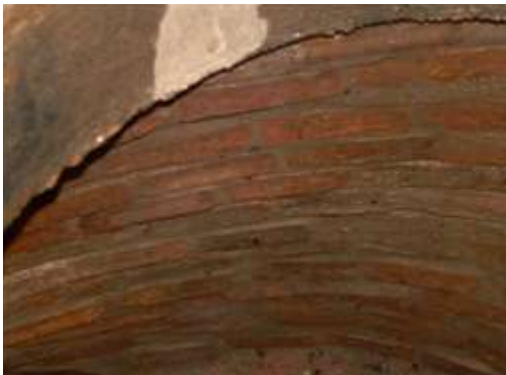
Defect

Frame Offset: **0** (in.) Condition: ☐ Sound ☐ Cracked ☒ **Leaks**

Infiltration: ☐ None ☒ **Joint** ☐ Cracks ☐ Mortar ☐ Roots ☒ **Wall**

Infiltration: ☐ None ☐ Joint ☐ Cracks ☐ Mortar ☐ Roots ☒ **Wall**

Frame leaks. Corbel and Barrel infiltration.

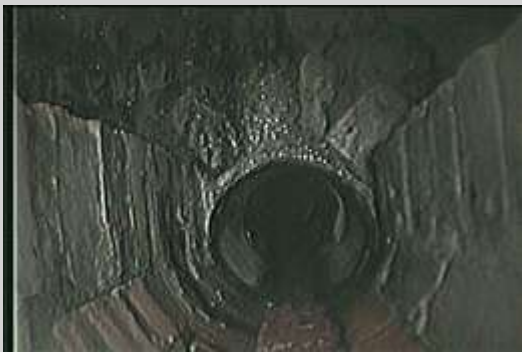
8 in. Circular Gravity Sewer Pipe Out @ 12 O'Clock

Deposits: ☐ None ☒ **Mud** ☐ Sludge ☒ **Debris** ☐ Grease

Silt Depth: **0** (in.) Deposits Extent: **Light**

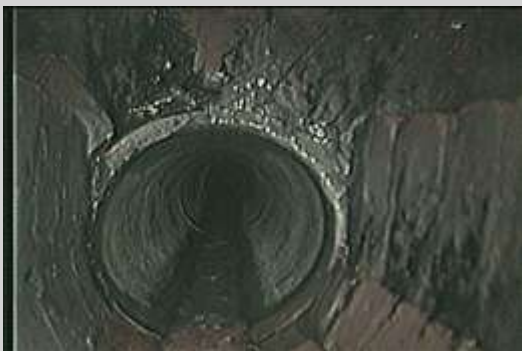
8 in. Circular Gravity Sewer Pipe In @ 6 O'Clock

Deposits: ☐ None ☒ **Mud** ☐ Sludge ☒ **Debris** ☐ Grease

Silt Depth: **0** (in.) Deposits Extent: **Light**

Infiltration: **Evidence** Pipe Seal Cond: **Unknown**
